# Monthly & Final Report

*From the*  
**Court-Appointed Monitor**  
*for*  
**Columbia Gas of Massachusetts**

**Submitted October 6, 2020**

***United States v. Bay State Gas Company, d/b/a Columbia Gas of Massachusetts***  
***(Docket: 20-cr-10066-FDS)***

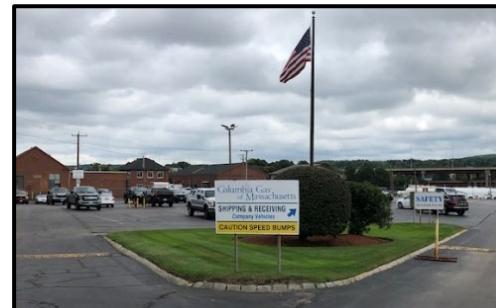
- *Lawrence Operations Center*

On September 10, 2020 members of the Monitor team visited CMA's Lawrence Operations Center (see photo at right). They toured the facility, examined its supply of emergency equipment, spoke with several employees, and interviewed a manager and a supervisor in a newly renovated conference room that can be used as a command center.

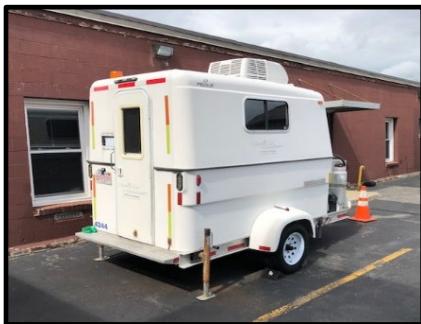
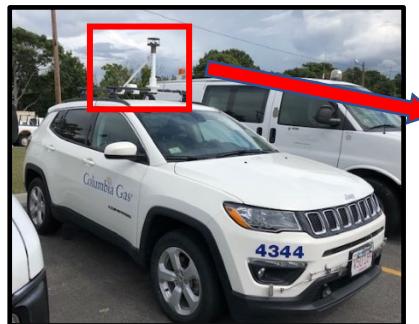
A small mobile trailer that can be used as a mini-command post during an incident was also examined at the Lawrence Operations Center, as well as a vehicle that had a Picarro leak detection system installed (see photos below).

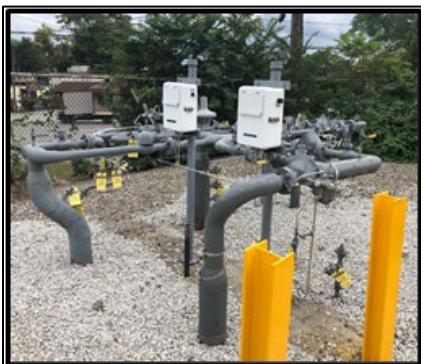
**Slam-shut Device**

The Monitor team members also toured a Point of Delivery Transmission/Regulator Station on Oak Street in Methuen. They viewed sensor lines at an above-grade regulator station and a “slam shut” device (see photos at left and below). They also spoke with Measurement and Regulation (M&R) technicians at length regarding the facility and also their recent experience with monitoring gas pressures during tie-in work.
